# FIRE RISK ASSESSMENT

Building Address: Gaslight Court, 37 Rookwood Way,  
Bow, London, E3 2XT

Date of Assessment: 15 August 2024

*General Needs Purpose Built High Rise Block.*

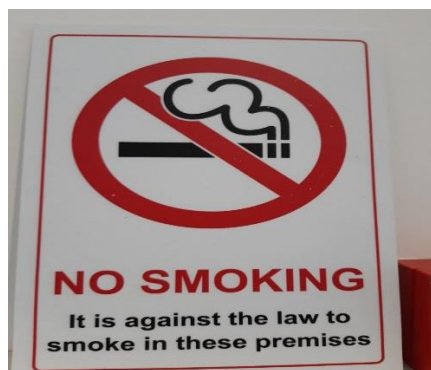
| | <i>'No Smoking' signage is displayed throughout the communal areas of the building.</i> | | | | | |

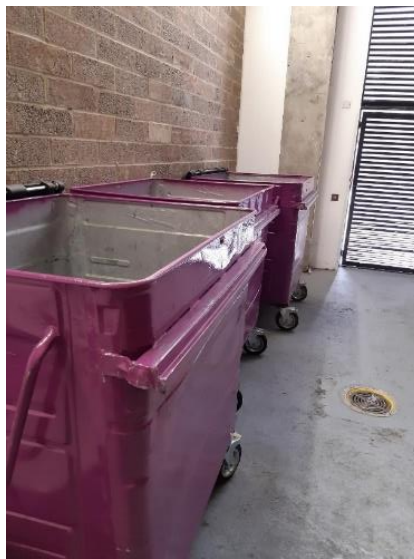
*Refuse holding area is located in the basement area of the block.*

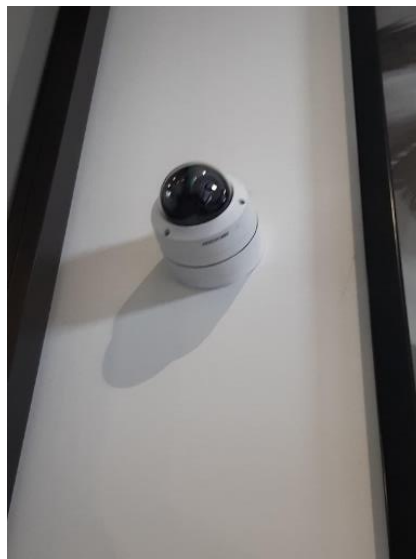
*CCTV is installed.*

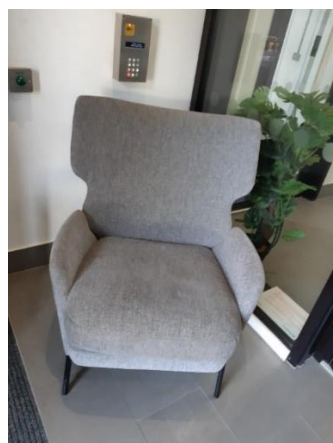
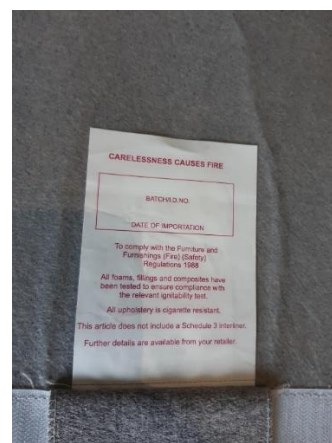
*Magazines and leaflets were witnessed in the entrance lobby.*

*The chair in the entrance lobby is fire retardant.*

| Ref | Recommendation | Location | Risk | Qty |
|---|---|---|---|---|
| 8.3. | The magazine and leaflets must be removed immediately, with the Neighbourhood Manager (NM) making regular inspections to ensure that all intakes, risers and communal areas remain clear and unobstructed at all times. | Entrance lobby.<br> | 1 | |

**8.3. The magazine and leaflets must be removed immediately, with the Neighbourhood Manage (NM) making regular inspections to ensure that all intakes, risers and communal areas remain clear and unobstructed at all times.**

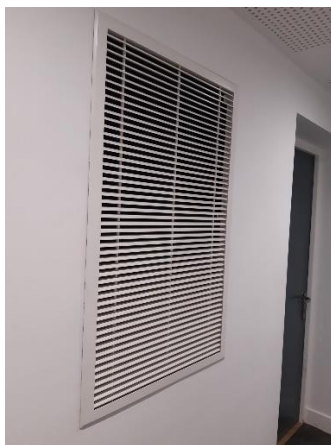
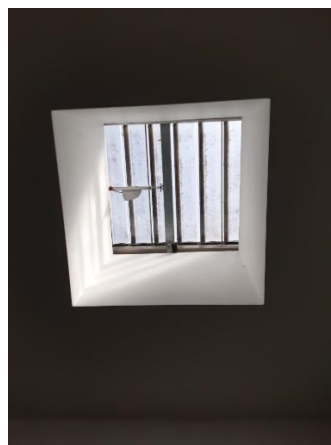
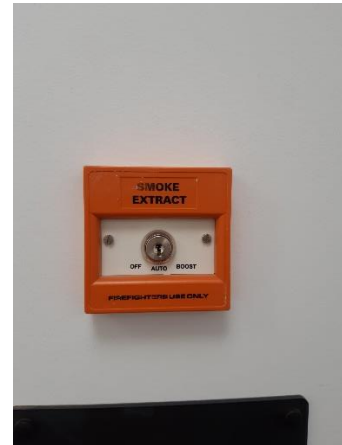
*There are two automatic opening vents provided at the top of the shared stairwell giving more than the minimum free area of 1.0m<sup>2</sup>. On each floor a smoke shaft provides ventilation to the enclosed circulation corridor, plus there is a ventilation grille incorporating a damper, between the lift lobby and stairwell.*

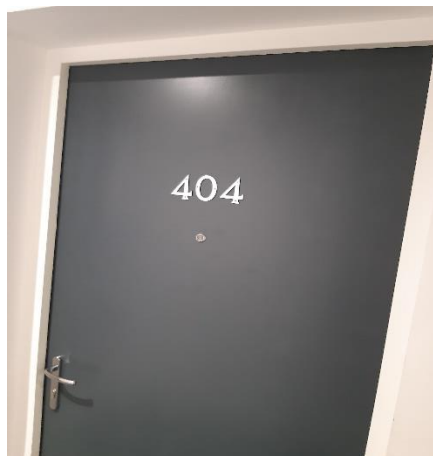
*The doors to Flats 201, 304 and 404 were inspected with all found to be suitable and sufficient.*

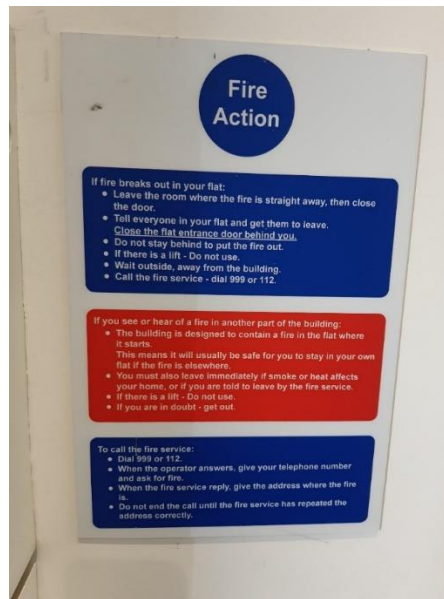
Fire Action Notices, displaying a Stay Put policy, are installed throughout the communal areas.

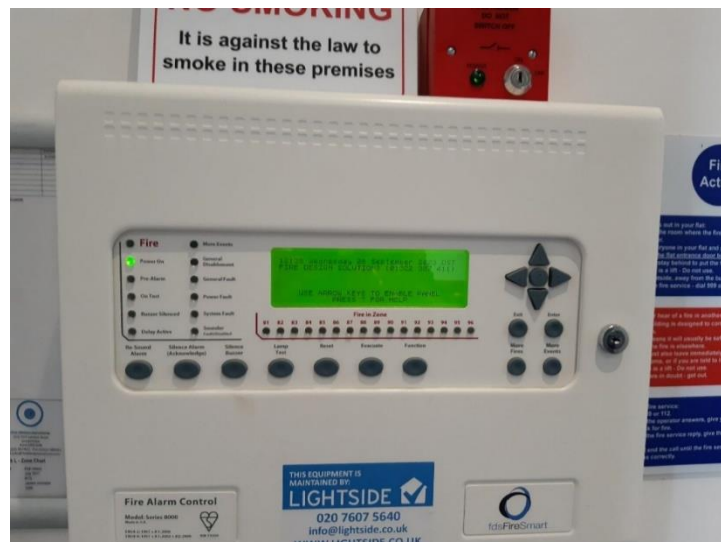
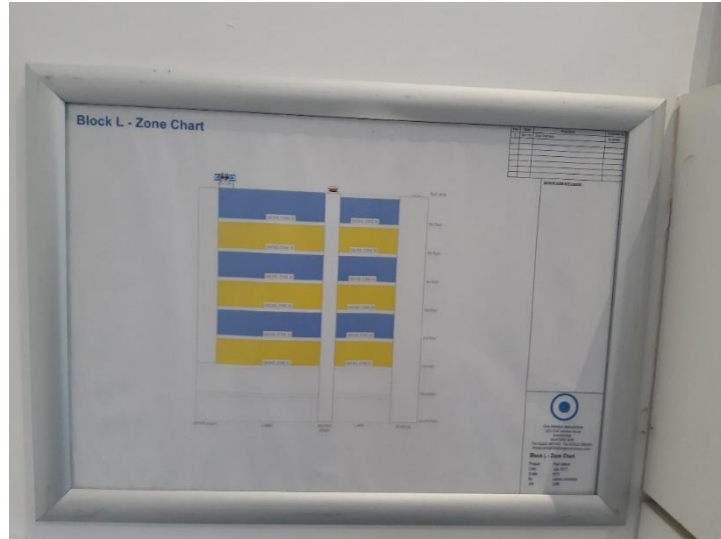
*A zone chart is displayed adjacent to the fire alarm panel in the entrance lobby of the block.*

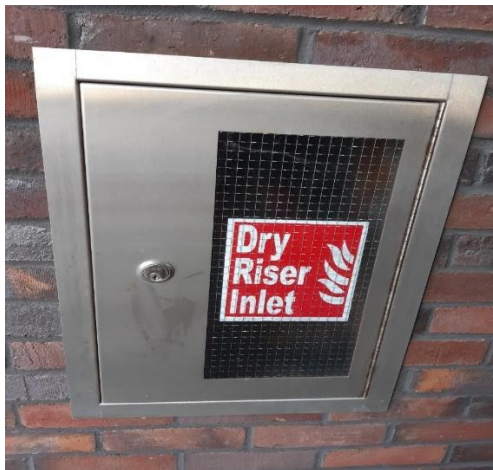
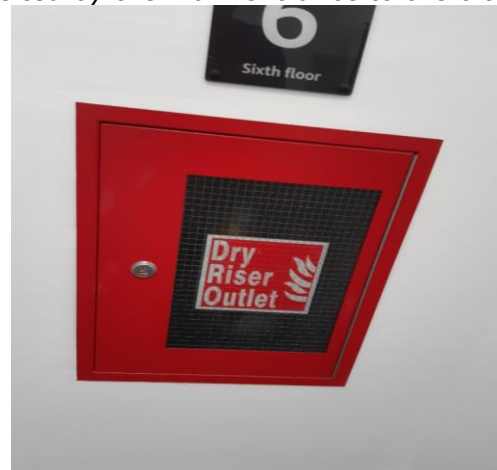
*There are dry risers with outlets in proprietary cabinets located within the stairwell shared with Adansbeck Court. The inlet is sited by the main entrance to the block.*

| Ref | Recommendation | Location | Risk | Qty |
|---|---|---|---|---|
| 20.6. | A competent person must be employed to carry out testing of the building's dry riser system. This must include an annual 12 bar wet test. All works must comply with BS 9990. All certificates must be uploaded onto EDMS immediately upon receipt. | Management. | 1 | |

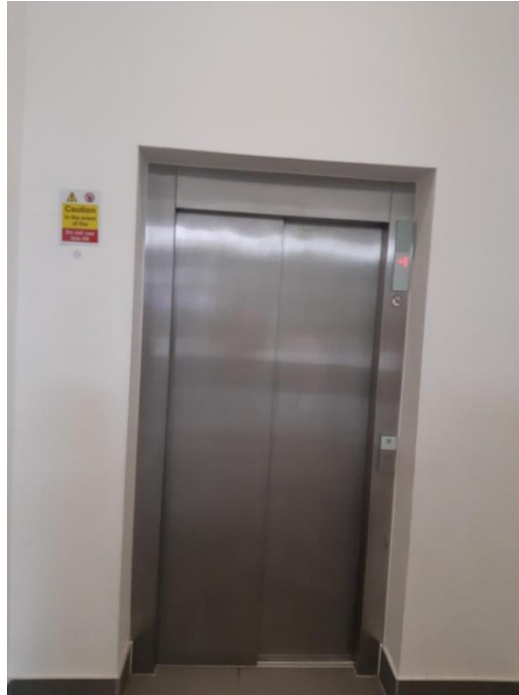
*A single accommodation lift is installed. A dedicated firefighting lift is installed in Adansbeck Court.*
